**ARCHEOLOGICAL INVESTIGATIONS
AT LAKEPORT PLANTATION
Summary Report, AAS Project 03-02
May 2003**

By
Randall L. Guendling

Archeological Investigations at Lakeport Plantation SUMMARY REPORT

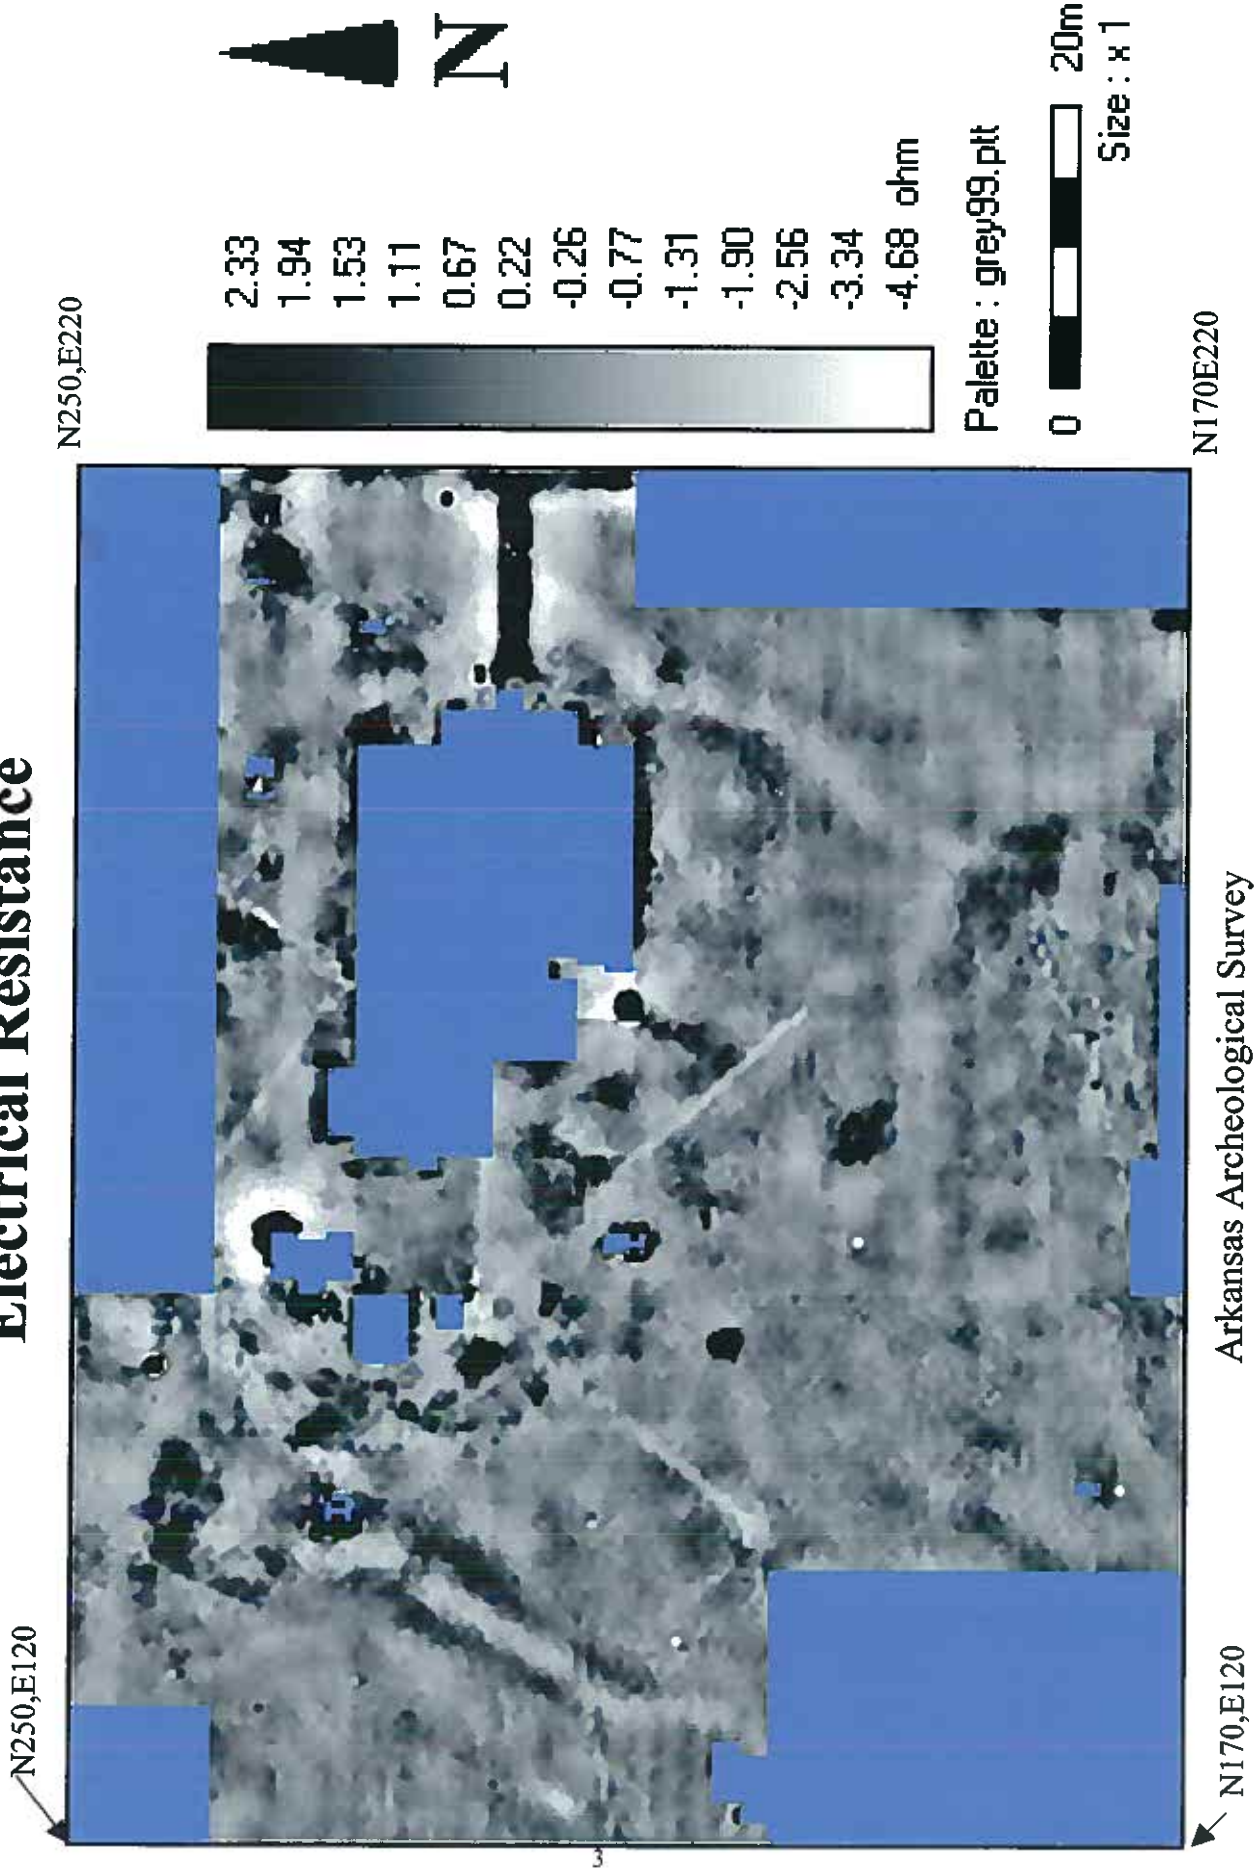
Figure 1. Grey palette image of resistivity values.

The front walkway was highly visible in the remote sensing map (Figure 1) and when scaled measured about three meters wide. We probed across the area of the image and hit a solid surface a few centimeters below the sod measuring 2.9 meters wide. Excavation at the edge of the walkway exposed a narrow brick walkway just under the present surface. Made of highly vitrified bricks laid end to end in a running bond, this narrow walkway lay on top of an earlier low-fired brick walkway. The portion of narrower walkway exposed was 35 cm wide and the earlier walkway extended 75 cm wider; both are only partial exposures of the south side of the front walk as identified in the geophysical map.

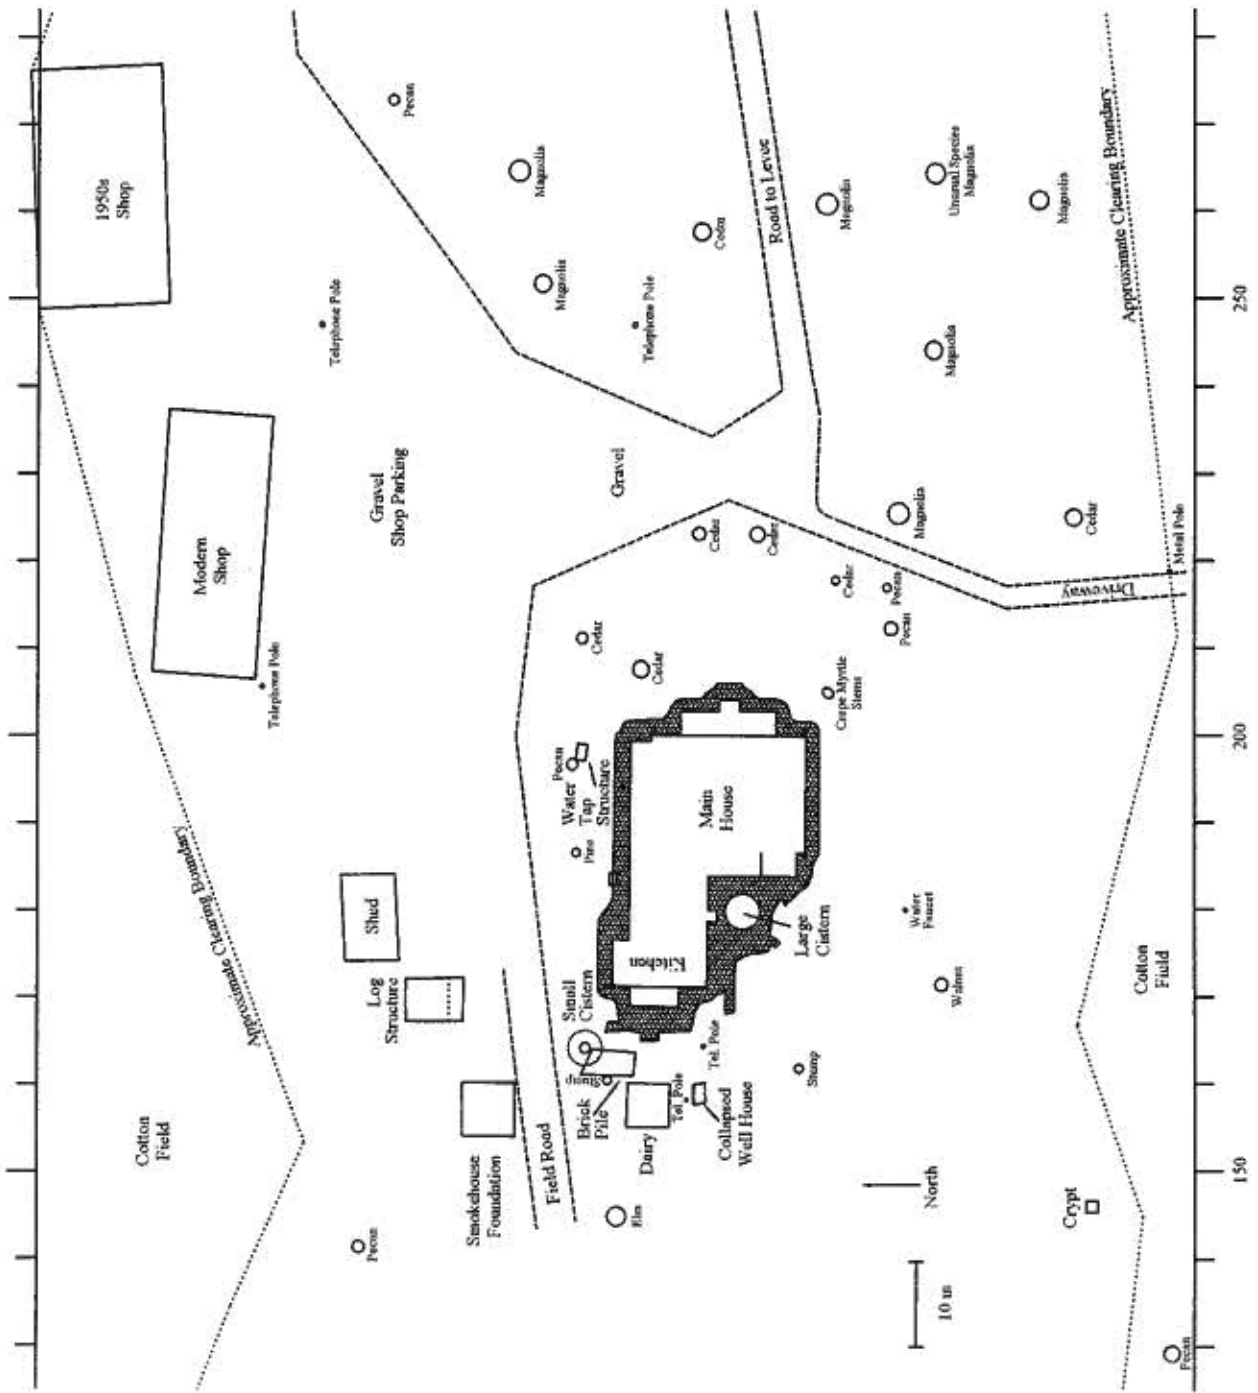
Figure 3. Plan of plantation core area with brick paving mapped.

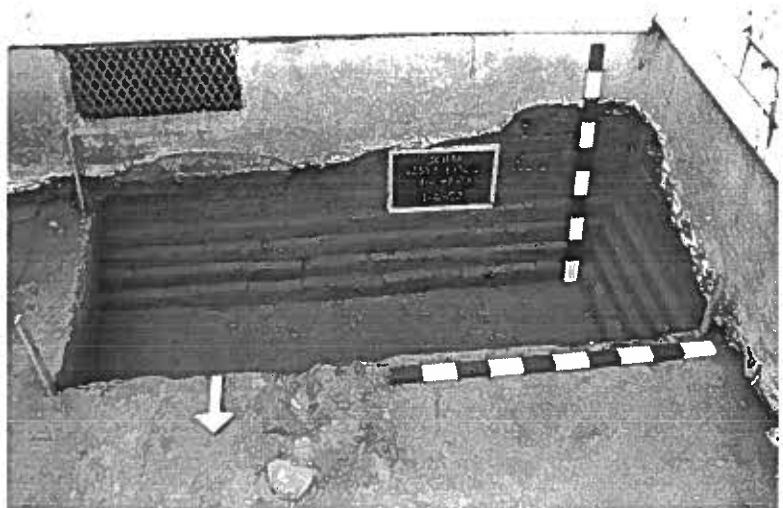
The original foundation wall exterior was covered with stucco made from the same soft lime mortar used to cement the bricks of the foundation together. Above bellum stucco has either weathered off or been overlain with modern Portland cement stucco. In a few places along the front of the house, the earlier tan stucco can be seen under the white Portland cement where it has deteriorated. Below the paving in the front of the house, original stucco still adheres to large sections of the foundation wall. In two units the original stucco extends to three courses below the paving where it forms a

Figure 4. Foundation test unit at juncture of east kitchen wall and north commissary wall. Note corbeled footer. (AAS Neg. No. 2002 5333)

horizontal lip over the first corbeled course, but a centimeter or two above the brick indicating the foundation was partially backfilled before the stucco was added.

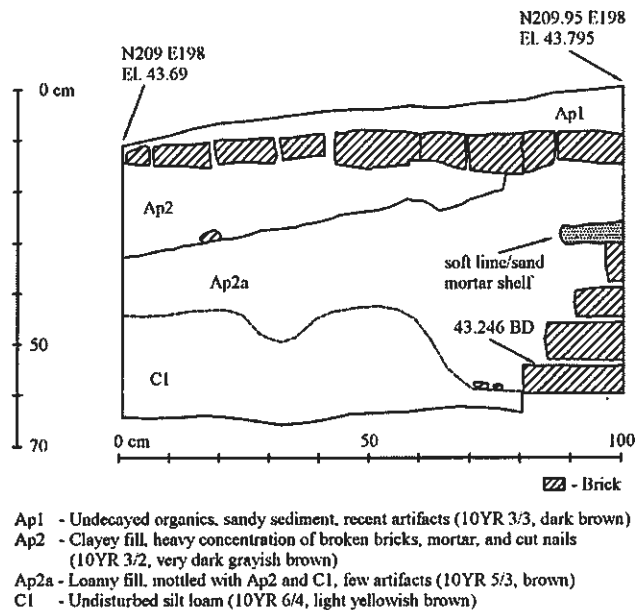
The foundation units were one meter wide, which should have been ample room to expose a builder's trench if present. Rather than a definable trench though, two fill deposits extended across the entire profile (Figure 5). Further, this same fill profile was found in all the foundation units opened around the exterior of the house and in the one chimney base unit under the house. This consistent profile can only be explained by large scale earth moving, rather than the more targeted hand-dug builder's trenches.

Prior to laying out the foundation the top of the ridge apparently was removed, possibly using mule drawn slip scoops well-documented in nineteenth century levee construction. The upper sediments were pulled away down to the undisturbed C horizon, and the footprint of the foundation leveled. Once the exterior foundation walls, porch piers, interior wall foundations, chimney footers and brick drains were built, the interior spaces were backfilled and the exterior spaces next to the foundation partially backfilled (Figure 5, Ap2a horizon) to the top of the corbeled footer. The exterior foundation walls were stuccoed, and the house framed and exterior sided. At some point during construction a very clayey fill was added (Figure 5, Ap2 horizon). This fill contains a heavy admixture of brick fragments, mortar and copious cut nails in all construction use sizes, indicating it was either in place during the most active construction or stockpiled at the edge of the immediate construction area.

Figure 5. Foundation test unit west profile wall, southeast corner of the house.

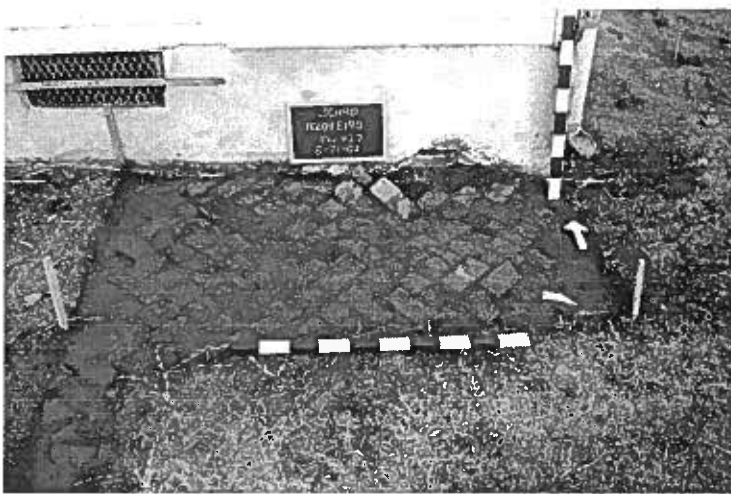
The paving is defined by a soldier course of bricks laid on edge along their long axis at the outside edge. The soldier course was laid in a sinuous pattern from the front walk curving to a straight line parallel to the porch, then curving again through the corner formed by the front porches and the house. It straightens across the front of the northeast porch then curves around the northeast and southeast corners of the house and parallels the length of the house (Figure 3). Behind the soldier course whole bricks are laid flat in a herringbone pattern filling in all the area between the edge and the foundation. Along the north and south facades the width of the paving averages about 1.5 m (Figure 6) and dipped away from the foundation.

Figure 6. Brick paving at southeast corner of the house before excavation. Soldier course is in the lower left corner. (AAS Neg. No. 2002 5145)

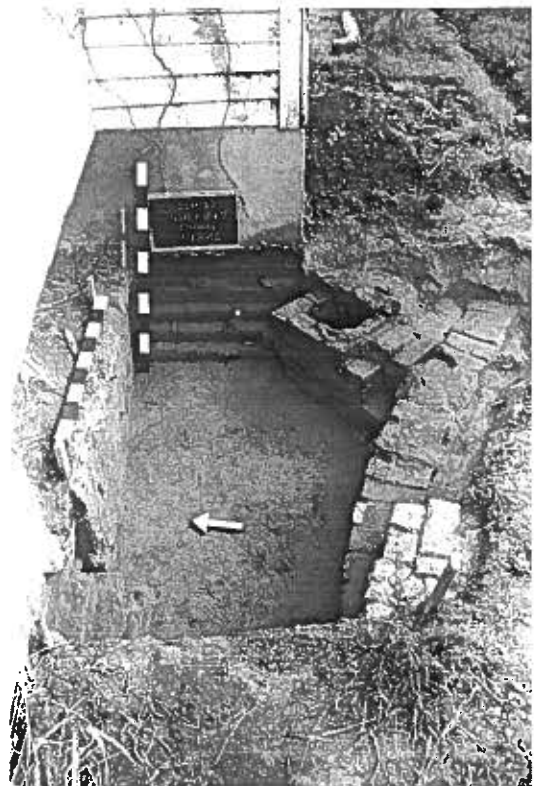
Figure 7. Excavated box drain and brick drain to large cistern at southwest corner of house. The lighter bricks at the lower right corner are paving bricks. (AAS Neg. No. 2002 5397)

The large cistern was similarly filled, but by only two drain boxes, one at the southeast corner and one at the southwest corner of the south facade of the house (Figure 7). The box and drain were just below the surface of the paving at the southeast corner of the house, and the drain became deeper as it progressed west under the paving. At the second drain box the drain began curving sharply to the north to clear the butler's pantry pier and enter the large cistern. This prompted a question: why is the smaller cistern filled by three box drains and the larger cistern only two?

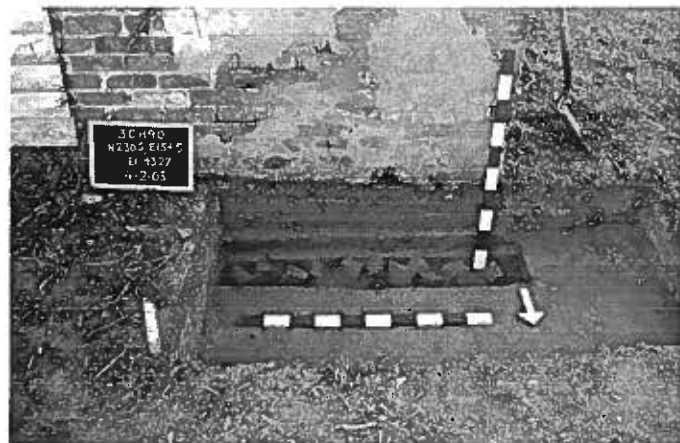
One excavation unit was placed at the northwest corner of standing brick dairy. Three different layers of artifact-laden fill capped the surface. A builder's trench appeared at 30 cm below the surface, measuring about 27 cm wide parallel to the north wall. It did not extend beyond the corner. The builder's trench was filled with $\frac{1}{2}$ bricks (Figure 8), but no other artifacts were found except a small piece of glass and two cut nail fragments. The footer was comprised of four courses of low-fired bricks, but only the top two were corbeled. The bottom two courses were aligned under second corbeled course.

The profile of the north wall of the unit showed no builder's trench on the west dairy wall. Instead, a thin line (ca. 2 cm) of fill was defined next to the second corbel, but the undisturbed C horizon is in direct contact with the second, third and fourth courses. This means that on the west side the dairy the builder's cut a straight wall into undisturbed sediments and bricks were laid against the dirt wall as a form. The stratigraphic profile exposed at the dairy is a C horizon overlain with three separate fill episodes, none of which correspond to the Ap2 horizons next to the house. The sediments underlying the dairy indicate the site is not part of the large

Figure 8. Builder's trench exposed at the northwest corner of the dairy. Note only two corbeled courses. (AAS Neg. No. 2003 2544)

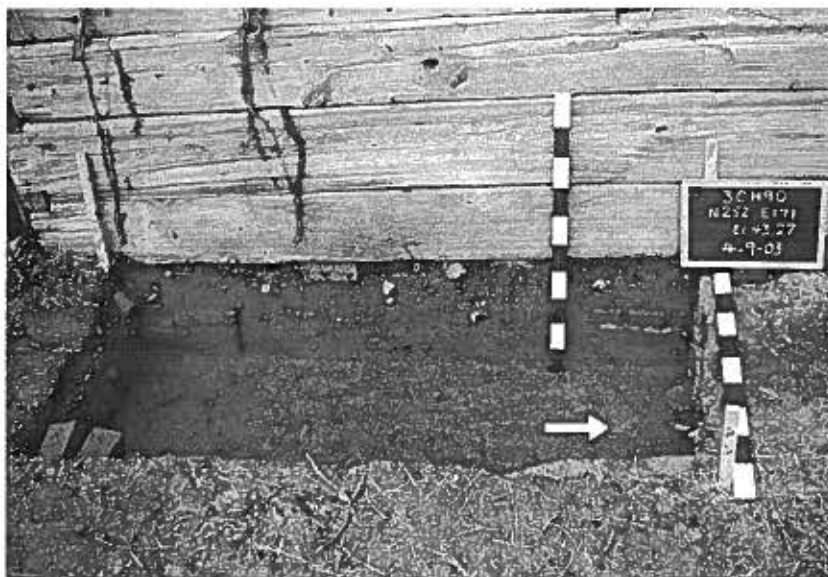
Two excavation units were placed to test an apparently undisturbed area along one wall. One unit was outside the east wall and one was placed parallel on the inside. Two areas of single courses of low-fired bricks were present under the wall at north and south ends of the outside unit. The brick courses were directly under the lowest log at the same elevation, but were 20 cm below the bottom of the log (Figure 9). Low-fired brick fragments and lime mortar fragments were recovered at the same level of the bricks. The two courses of bricks appeared to be the remnants of demolished piers from an earlier structure. A jumble of low-fired bricks was found in the north end of unit. The north pier appears to be resting on bed of mortar in turn resting on an undisturbed B horizon. Artifacts were plentiful, but mainly agricultural, though some cut nails and domestic items could be from a cabin occupation. The inside unit exposed the west side of the same piers. The bricks at north end formed a single course on the same mortar bed. A second jumble of low-fired brick was buried at the south end of the unit, but several were aligned with single course on exterior. This would make the pier about 30 cm (three wythes) wide.

The piers are buried under about 20 cm of fill and do not appear to have supported the present log wall. The north pier appears tumbled down to the east and the south pier tumbled to the west during purposeful demolition. Although the log structure may well be quite old, it was not original to the building site and may have been moved in from elsewhere after the previous structure was removed.

Figure 9. Two pier remnant brick courses in profile wall under lowest log of cabin. Note mortar bed under the brick at the north end (right side) of unit. (AAS Neg. No. 2003 2604)
