Lakeport Plantation Restoration

Technical Report No. 1

Parge Coating

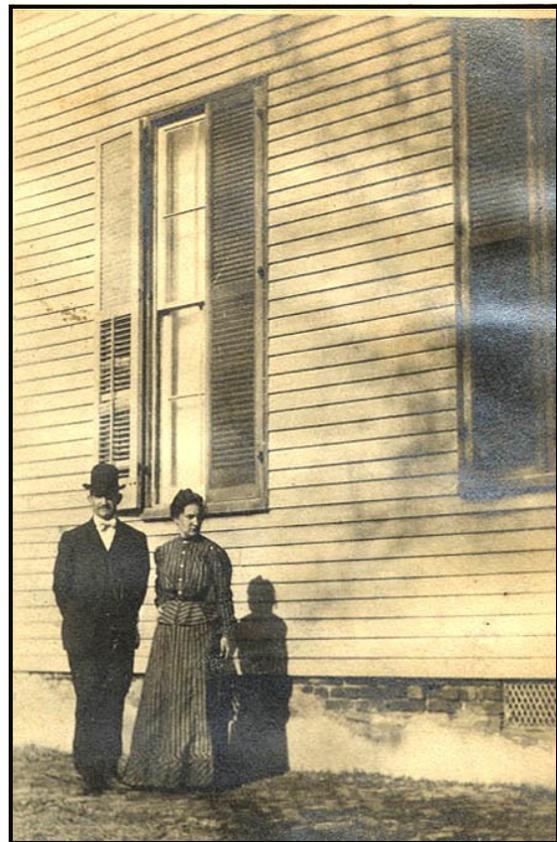
This photo of Lakeport Plantation house, taken during the early 1900's, shows the original parge coating on the foundation walls. This photo was provided by descendants of the Johnson family.

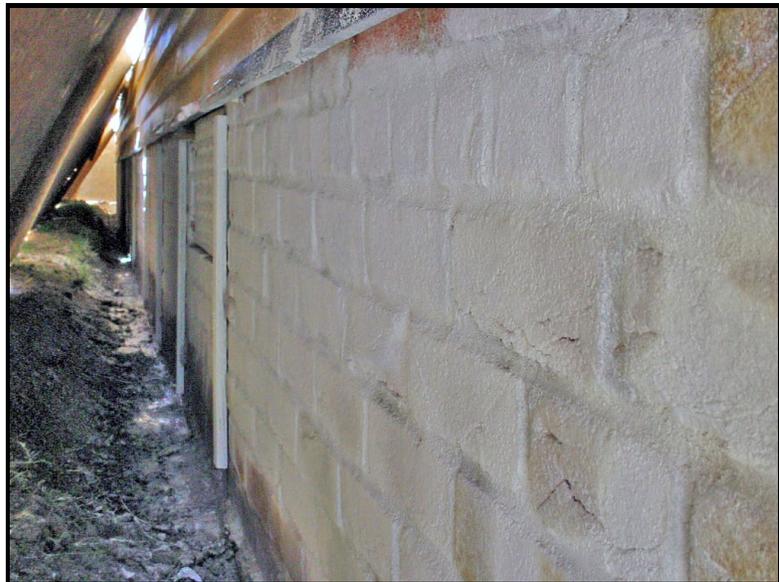
This photo shows the foundation walls of Lakeport Plantation house after the limewash was applied. Notice how the walls have been covered with sheets of plywood to protect the limewash from the sun to prevent quick drying.

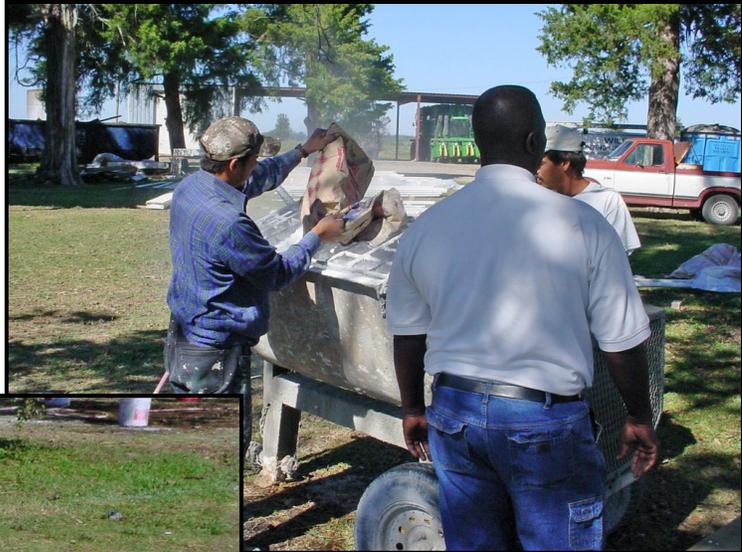
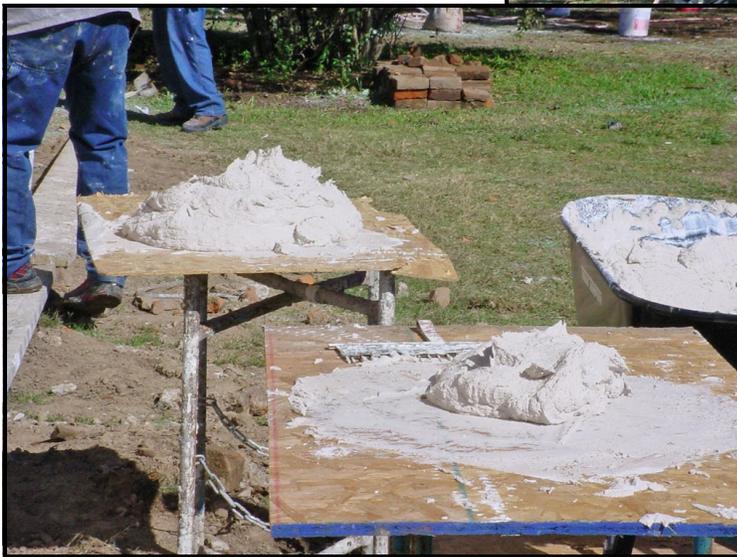
Photos of the restoration crew preparing the lime-based mortar mix used for parge coating the exterior foundation walls of Lakeport Plantation house.

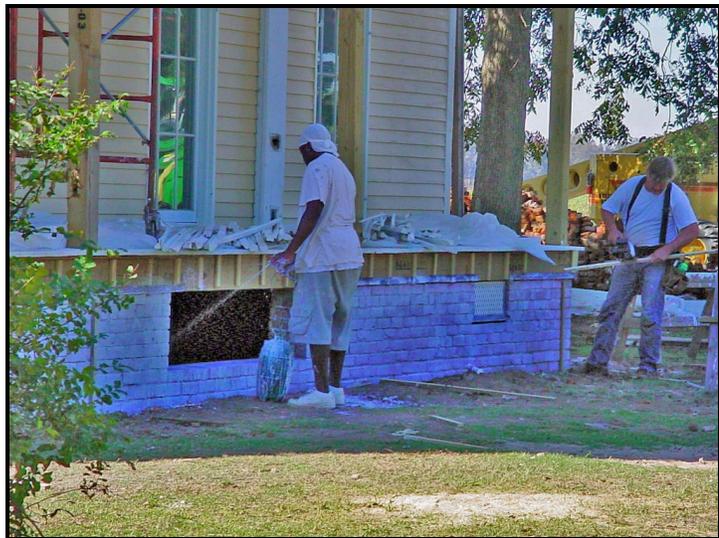
The photo above shows a restoration crew member misting the coat of limewash which will allow it to dry without cracking or flaking. To his right another crew member is applying the thin strips of wood called screeds which will be used to apply the plaster evenly.

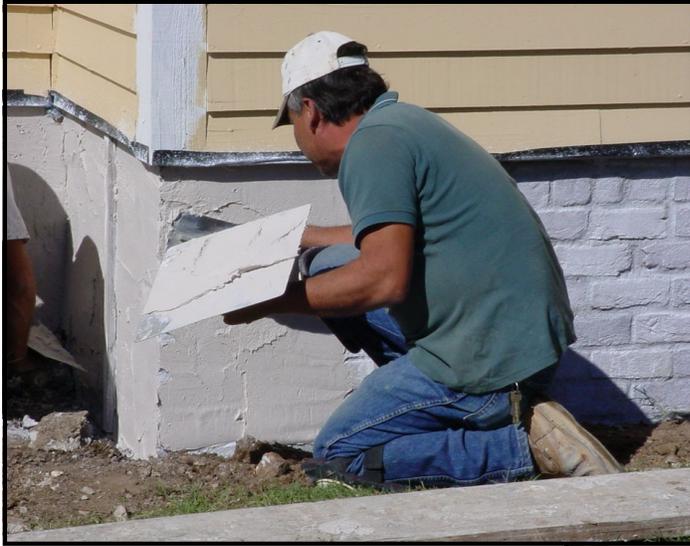
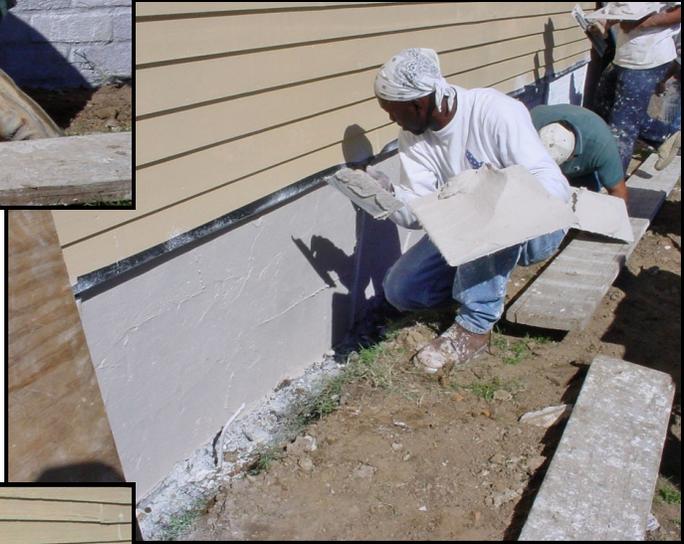
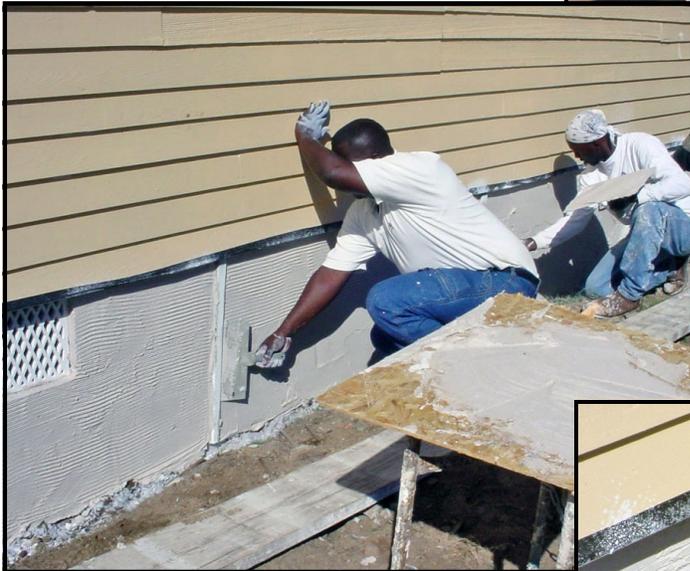
The photos at left and below show the scratch coat being applied to the foundation walls of Lakeport Plantation house.

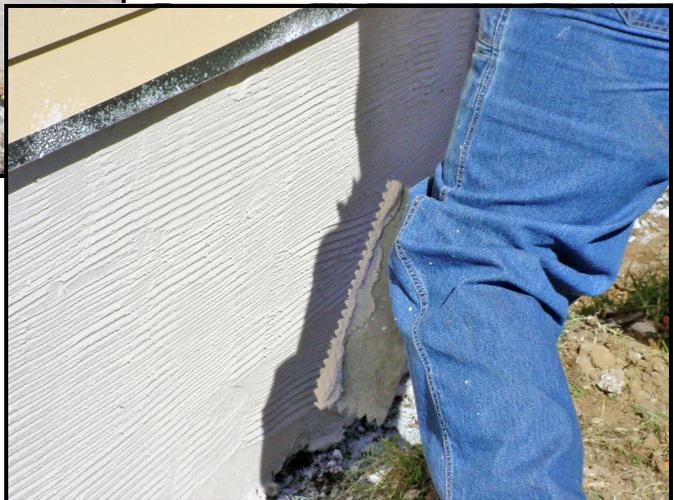
The photo at right is a close-up of the scratch coat after being raked or "scratched".

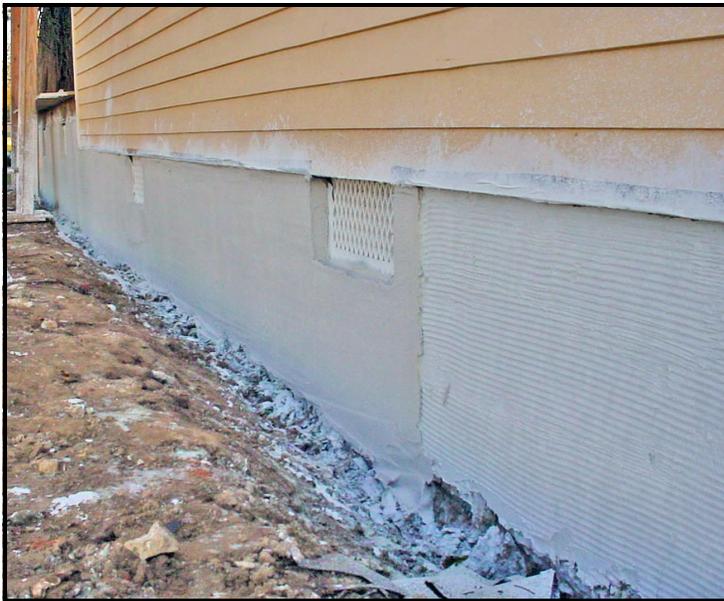
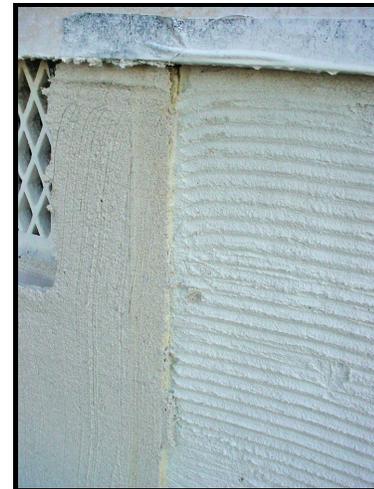
The photo at left shows a view of the scratch coat and brown coat applications side by side. The photo above shows an up-close view.

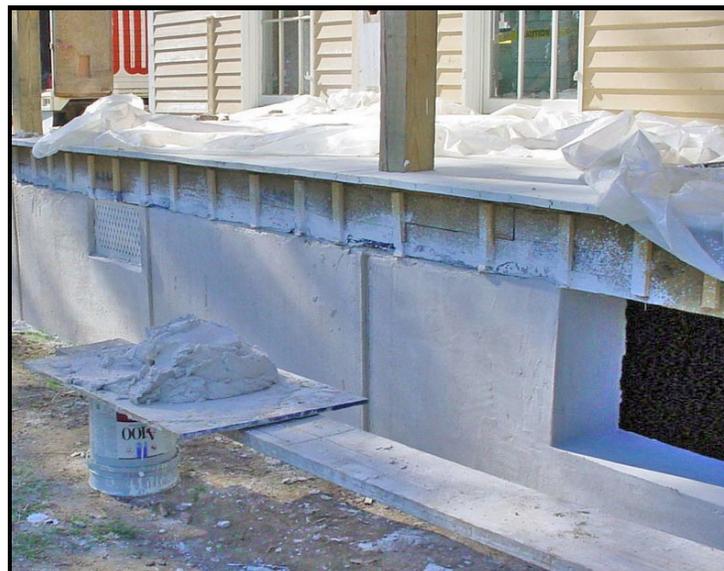
The photo at right shows the lime mortar ready to be used to fill voids left by the screed strips when removed after the brown coat was applied.

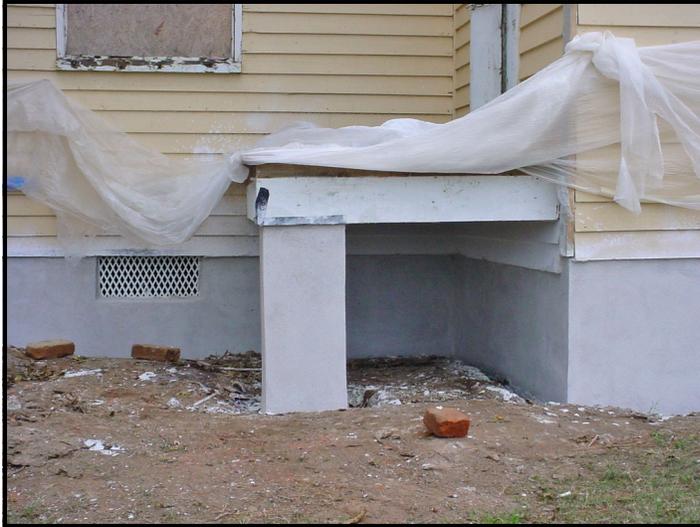
The photo at left shows the finished parge coating on the north side of Lakeport Plantation house. Notice the sheets of plastic attached to the siding of the house. The plastic was used to cover the plaster and protect it from the weather, allowing it to cure properly.

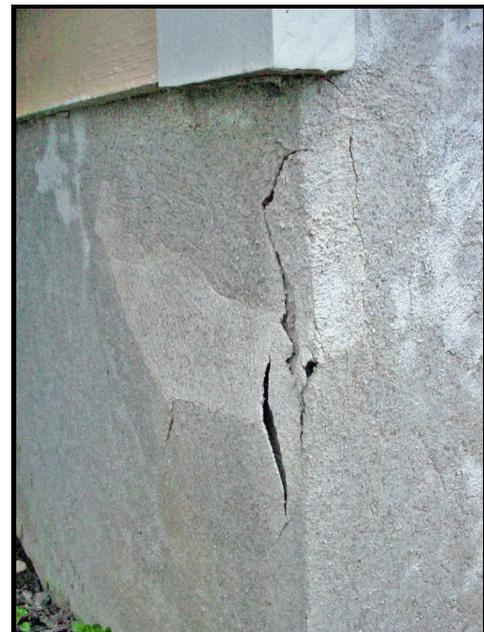
The parge coating on the foundation walls of Lakeport Plantation house has failed in several areas. In some areas the plaster has cracked and buckled and in other areas it is pulling away from the foundation wall. Some of this is due to the brick and plaster not being dampened enough to assure a tight bond during application. The modern brick that was used to replace the foundation walls is a harder brick than the original and is not as porous, meaning that it does not absorb moisture as easily. The modern brick would have required prolonged irrigation to become damp enough for the plaster coating to bond tightly.

The photo above shows the parge coating on a corner of the foundation wall where it has cracked and buckled. This is largely due to the plaster not being dampened enough to assure a tight bond during application.

Finished parge coating should be given coats of limewash periodically as a maintenance procedure. The limewash will continue to protect the parge coating and fill any hairline cracks that may have developed, preventing the cracks from becoming larger and allowing moisture to enter.
